June 20, 1996

On Thursday May 30, 1996 we conducted an inspection of the Atlas mine site. The purpose of this inspection was to evaluate remedial activities recently completed by the responsible party (RP), determine if additional improvements are necessary, and identify areas of the site that could be revegetated. Participants were:

SKETCH OF ATLAS SITE
DRAINAGE IMPROVEMENTS
OBSERVATIONS FROM
5/30/96 INSPECTION

=====
Client: U.S. Environmental Protection Agency E&E Job No.: ZM6000
Site: Atlas Asbestos Mine Site 5/30/96
Camera: Make Yashica AF-mini SN N/A
Lens Yashica AF-mini SN N/A
=====

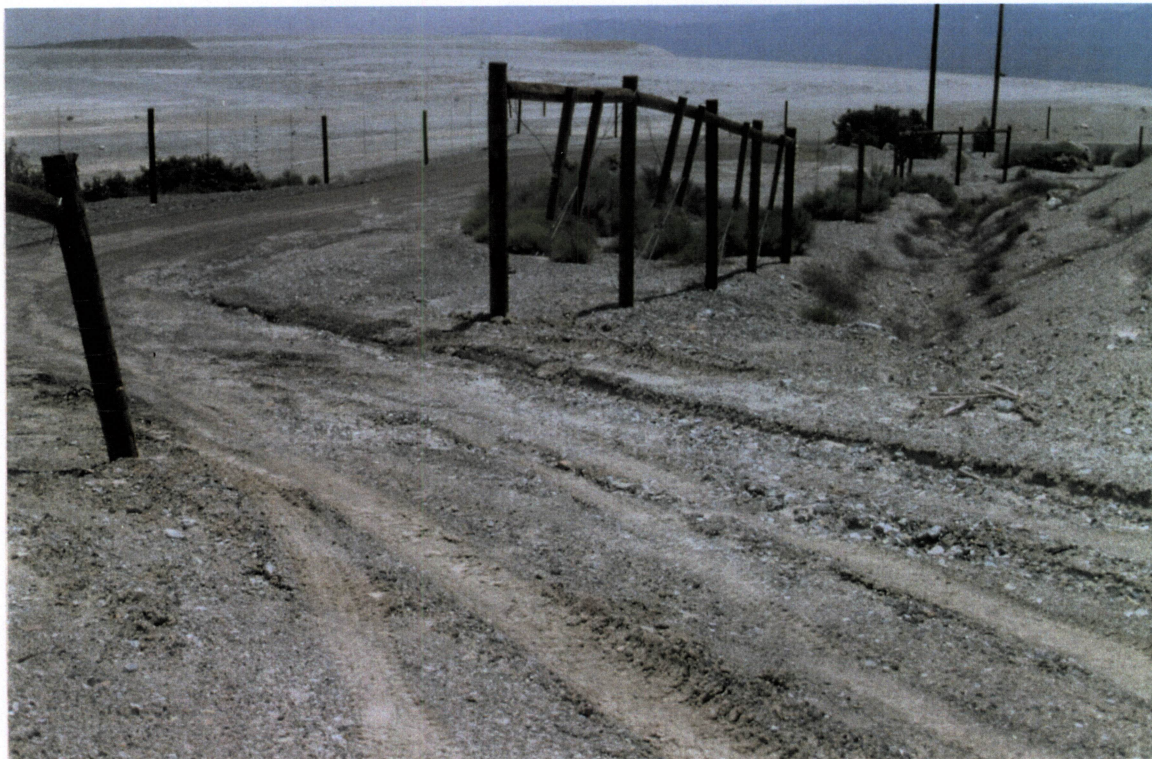
- c) Road drainage - Road drainage has been improved on both sides of the chip sealed road near the entrance to the mill area (see attached sketch). The RP will need to cut a ditch from the upper mine road to induce runoff into the drainage ditch west of the chip sealed road (see photograph 1). Drain rock placed where the drainage ditch west of the chip sealed road crosses the access road to Pond B should be redistributed allowing flow across the access road (see photographs 3 and 4). The diversion berm

①
At the upper mine road looking east towards the chip sealed road. Runoff from the upper mine road will be diverted into the ditch to the right of the BLM fence in this picture.

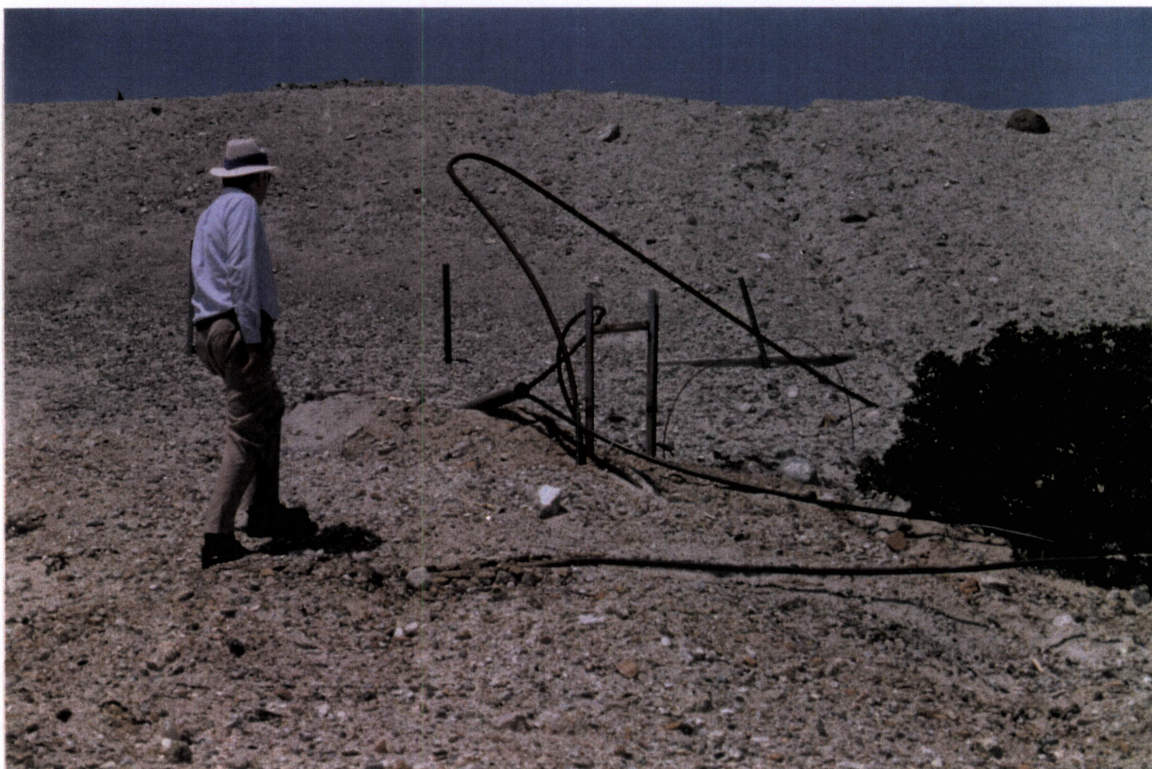
②
Debris near the former mill site. The PRP is required to dispose of all site debris

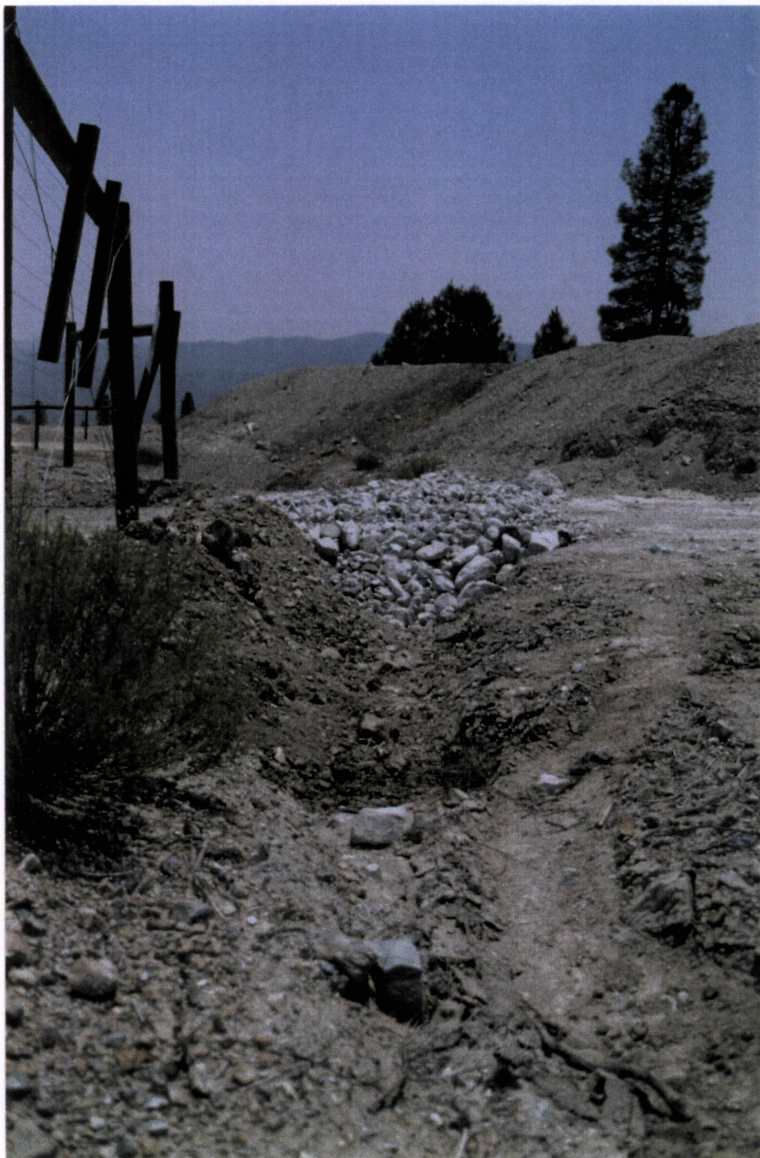
(3)

Side view of the road to
Pond B at the drainage ditch
west of the BLM fence. The
rock looks like it will prevent
runoff from flowing through the
drainage ditch.

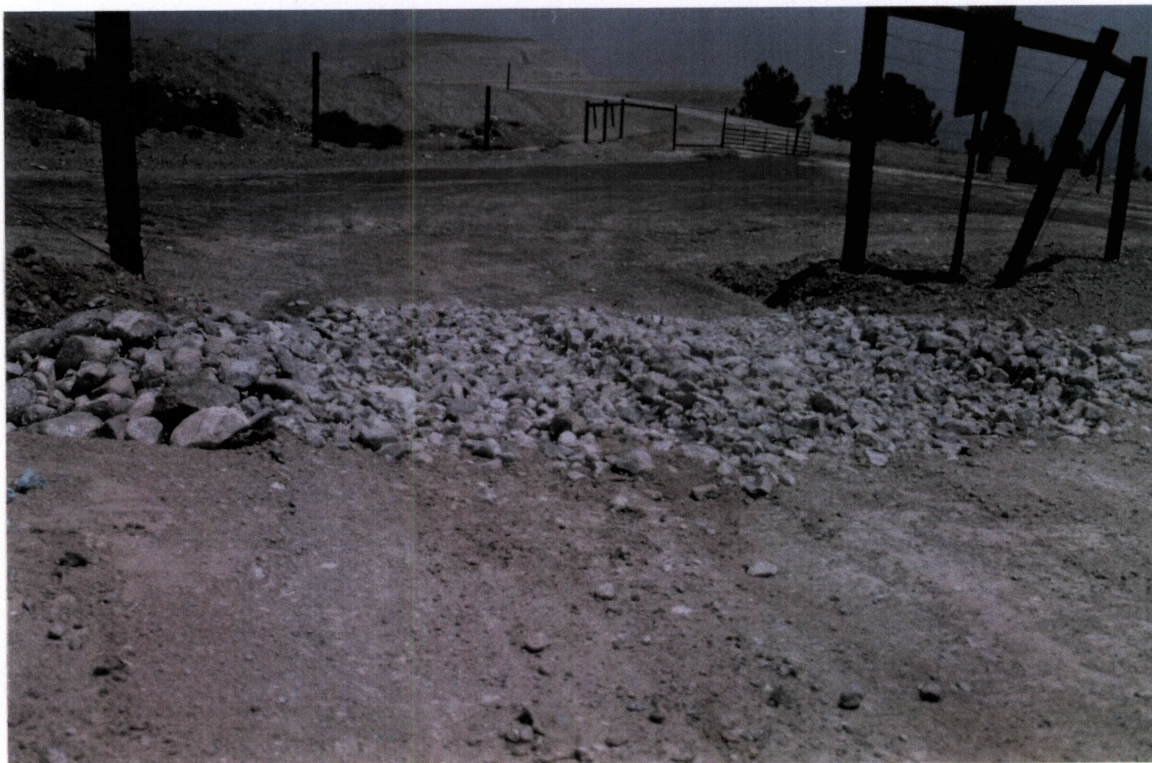
- ④ The road to Pond B looking east toward the chip sealed road. Rock has been placed flush with road and will prevent flow through the drainage ditch.
